3D-FIB characterization of wear in WC-Co coated composites

Abstract. In this work 3D visualization of wear in milling inserts has been investigated by Focused Ion Beam tomography. It has been observed that the morphology of the cracks differs in the z-axis direction, allowing particular characteristics of the microstructure and wear evolution to be visible. Two types of cracks develop: principal and lateral cracks. The formation of lateral cracks is strongly influenced by the degradation of the binder phase in the regions surrounding the principal crack. The lateral cracks and the deflection of the main cracks present a particular semi-elliptical geometry, which correlates with the stress field originated during the input of a cycling load in a fatigue condition.

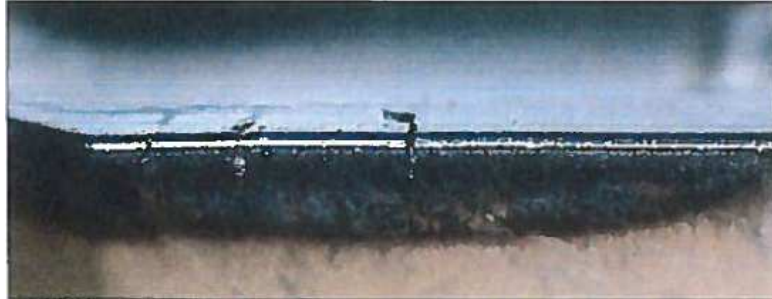
Comb cracks were generated by wet milling tests in grey cast iron. Using this method the inserts are subjected to a high thermo-mechanical cycling condition due to the use of coolant, which causes the formation of comb cracks perpendicular to the cutting edge. In this test the tool life is mostly determined by chipping as a consequence of the comb cracks. So to avoid chipping and make the comb crack visible the test was stopped at 25% of the total tool life (Fig.1.).

Figure 1: Stereographic image of the insert edge after the milling test. 3 comb cracks are clearly visible.

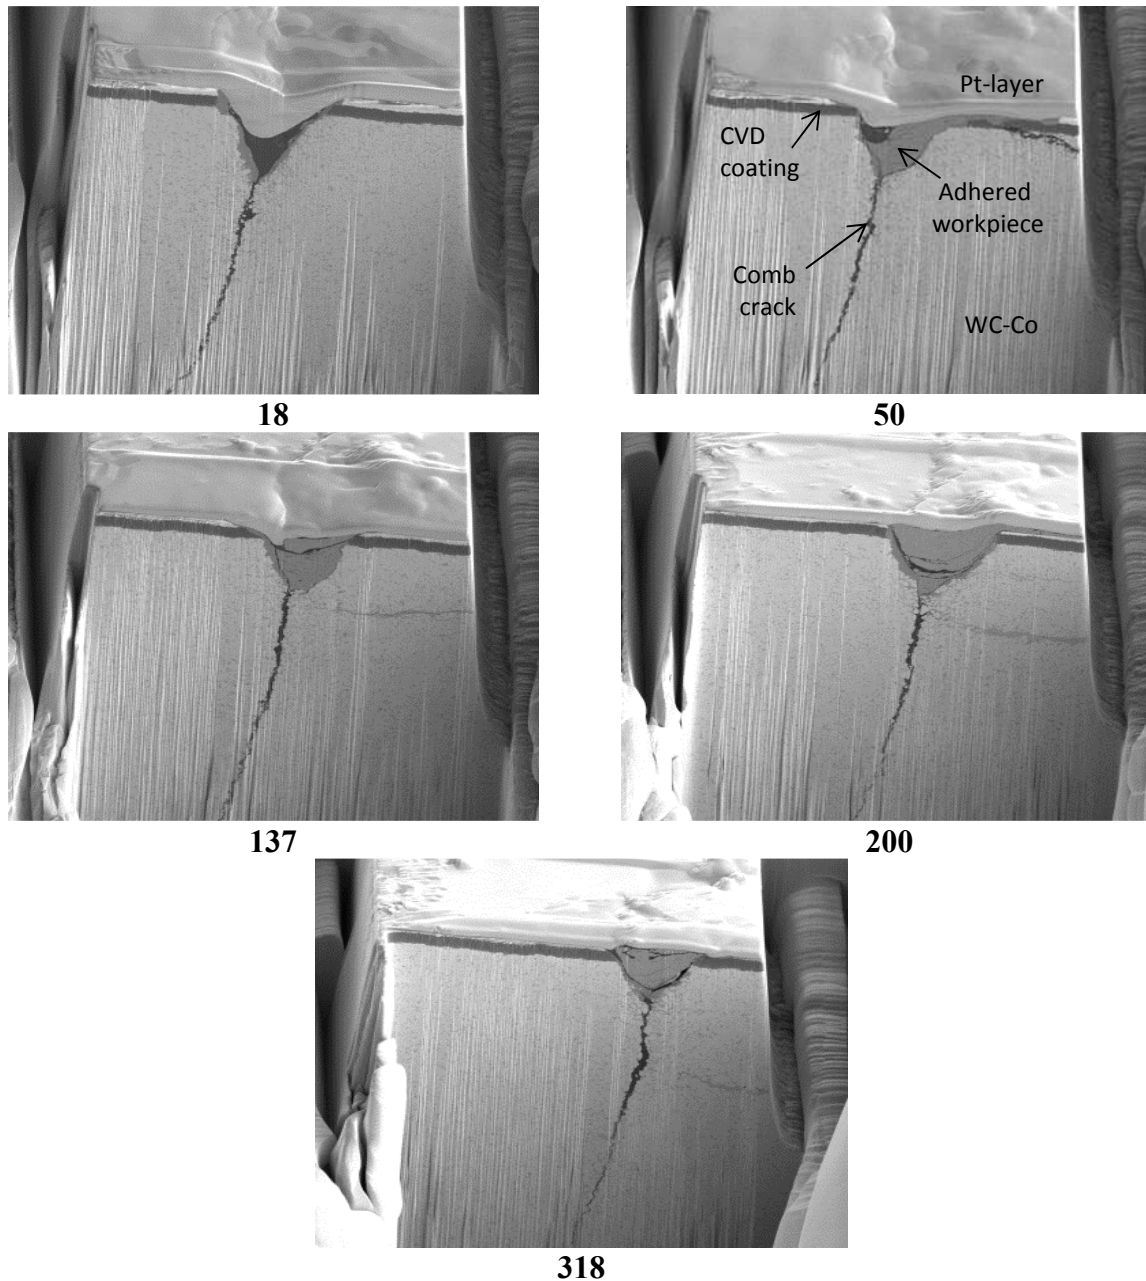
Figure 3 shows a series of images taken by the SEM (slide 18, 50, 137, 200 and 318) which were used for the 3D reconstruction. The images show the microstructure of the region around the comb crack at different distances from the flank surface (z-axis).

These images provide valuable information which is not possible to observe from a single 2D image. In particular the microstructural changes connected to the region around the crack are visible. For example the amount of workpiece material micro-welded to the cutting material varies inside the crack. Also the morphology of the wear track on the crater surface changes in the z-direction. Most interestingly it is observed that other cracks parallel to the edge line are visible. These lateral cracks are inside of the material as shown in slides 50, 137, 200 and 318. It can be observed that the microstructure around the lateral crack region is different compared to the initial microstructure of the material not affected by the wear. The distance of these lateral cracks varies as function of depth (z-axis) which may be assumed as independent cracks; however the 3D reconstruction will allow us to observe that this variation of depth to the edge line surface of the lateral cracks is connected to a particular morphology of them.

Figure 3: SEM images used for the reconstruction, showing microstructure changes at the different places of the region of interest.

Furthermore the formation of lateral cracks may be connected to microstructural changes in the region surrounding the crack, such as depletion of binder by chemical attack of the cooling media, as shown by the 3D sectioning in Fig. 3. The propagation of cracks may be dominated by the interfaces WC-to-Co, which depends on the particle size, distribution of the WC grains but also on the binder composition and the interfacial energy of WC/WC and WC/Co interfaces [7].

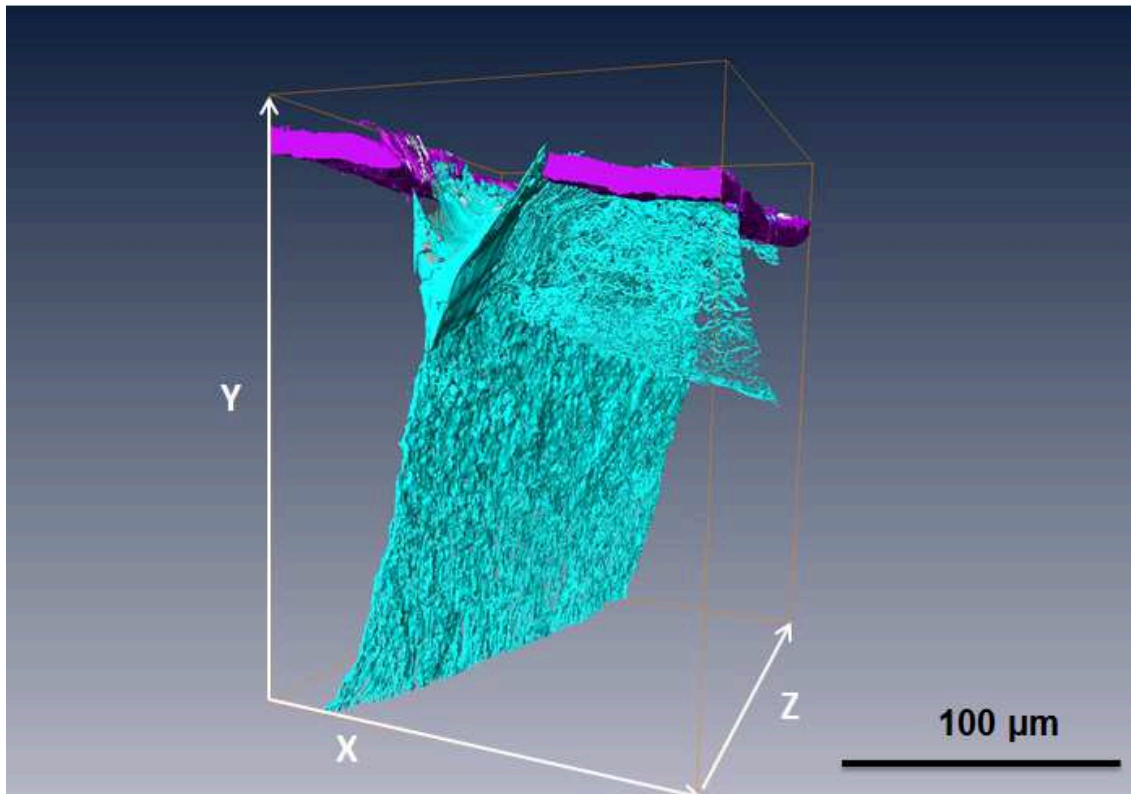
From the reconstruction it is observed that, by connecting the lateral cracks images in the 3D reconstruction, they present a particular morphology. The lateral crack has a semispherical morphology, which connects to the crater surface of the insert. This morphology can be more visible if the 3D reconstruction of the lateral crack is intercepted by a dark plane, as shown in Fig. 5. The lateral cracks present this particular form due to the fact that they are formed by the cycling mechanical load (fatigue condition) during the milling process.

Figure 4: 3D visualization of the comb crack investigated. The crack is marked with Cyan and the coating is marked with Violet.

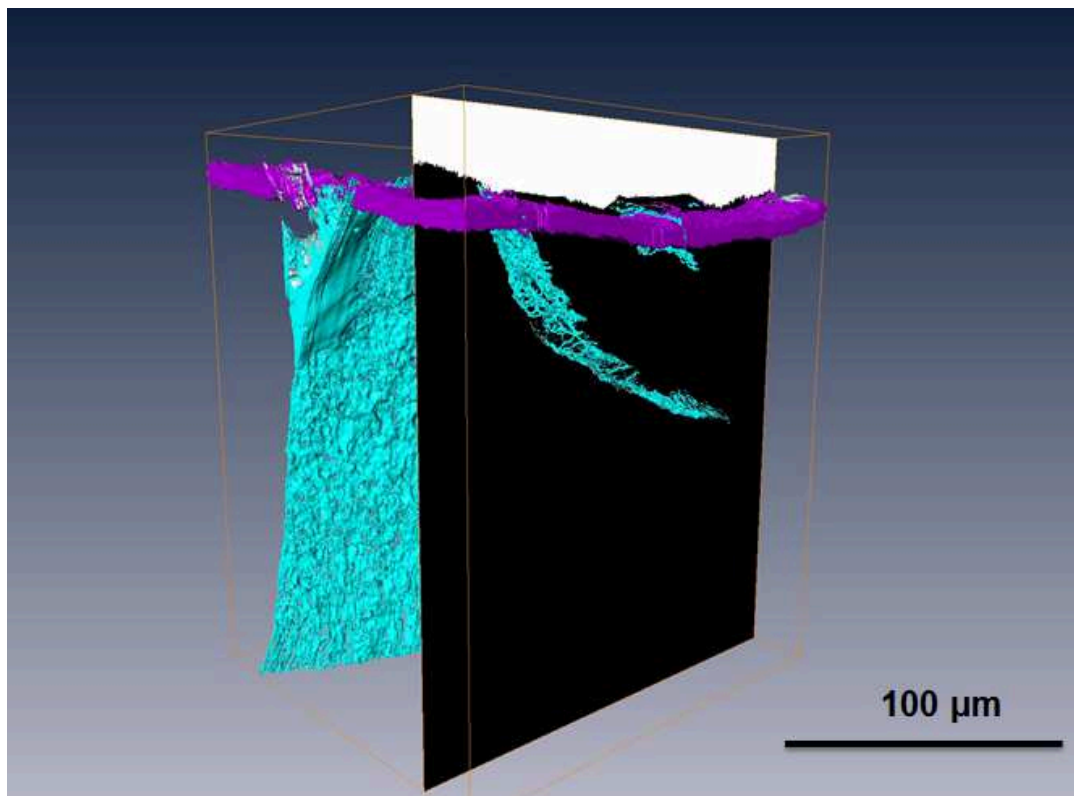
This is typical for brittle materials under cycling (increase/decrease) load condition, as demonstrated by Hutching [5]. It is remarkable that this particular form seems to be connected to the stress field acting in the cutting edge during the machining process, since the stress distribution of forces has the same semispherical form as the one observed in these lateral cracks. This correlation between stress and crack formation has been modelled by Sergejev et al in WC-Co cemented carbides [6]. They carried out theoretical calculations on the geometry of fatigue cracks on cemented carbides developed from cyclical loading (indentation cracks for different indentation loads); and the connection to lateral crack formation. It was determined that the number of lateral cracks that would be observed from one cross section of cemented carbide was dependent on the loading force and the number of loading cycles. The propagation of the primary lateral cracks was considered as giving way for surface fatigue fragments formation. The lateral cracks were determined to propagate with an elliptical form towards the free surface of the material.

Figure 5: The principal crack with the lateral crack, parallel from the surface. A black plane has been drawn in the y-z plane in order to visualize the morphology of the lateral crack.
