3D-FIB characterization of wear in WC-Co coated composites

Abstract. In this work 3D visualization of wear in milling inserts has been investigated by Focused Ion Beam tomography. It has been observed that the morphology of the cracks differs in the z-axis direction, allowing particular characteristics of the microstructure and wear evolution to be visible. Two types of cracks develop: principal and lateral cracks. The formation of lateral cracks is strongly influenced by the degradation of the binder phase in the regions surrounding the principal crack. The lateral cracks and the deflection of the main cracks present a particular semi-elliptical geometry, which correlates with the stress field originated during the input of a cycling load in a fatigue condition.

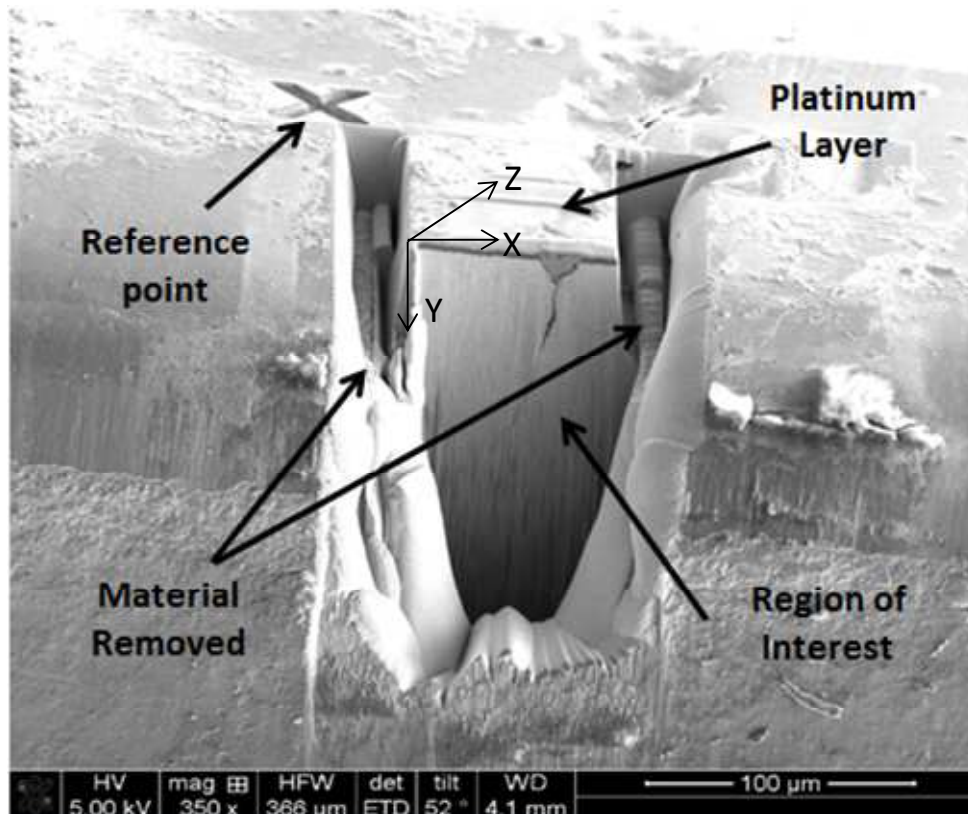
In Fig. 2 an image of the comb crack region after some sectioning in the FIB is shown. The material removal during the serial sectioning was stopped after realizing that no change in the microstructure was taking place. The total amount of images was 400. 319 sections were used to make the reconstruction.

Figure 2: SEM image of the sample during the FIB tomography.
